RE: Mid Valley Shopping Center Phase One Historic Assessment

**DPR 523A and 523B forms for the Mid Valley Shopping Center**

Page 1 of 42 Resource name(s) or number (assigned by recorder) Mid Valley Shopping Center

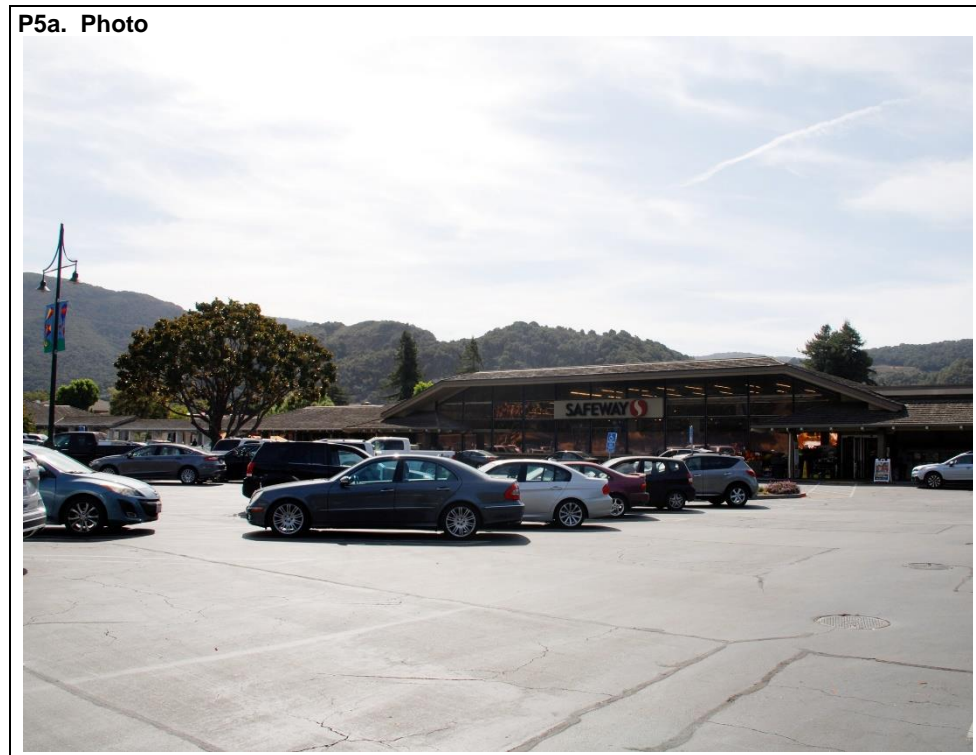
P5a. Photo

\*P5. Photo: View south toward Building A, October 11, 2019.  
 \*P6. Date Constructed/Age and Sources:  historic 1966-1982, plan drawings, historic newspaper articles.  
 \*P7. Owner and Address: The Stanley Group 2275 Winchester Blvd., Campbell, CA 95008  
 \*P8. Recorded by: Page & Turnbull, Inc. 170 Maiden Lane, 5th Floor San Francisco, CA 94108  
 \*P9. Date Recorded: 10/11/2019  
 \*P10. Survey Type: Intensive survey  
 \*P11. Report Citation: None

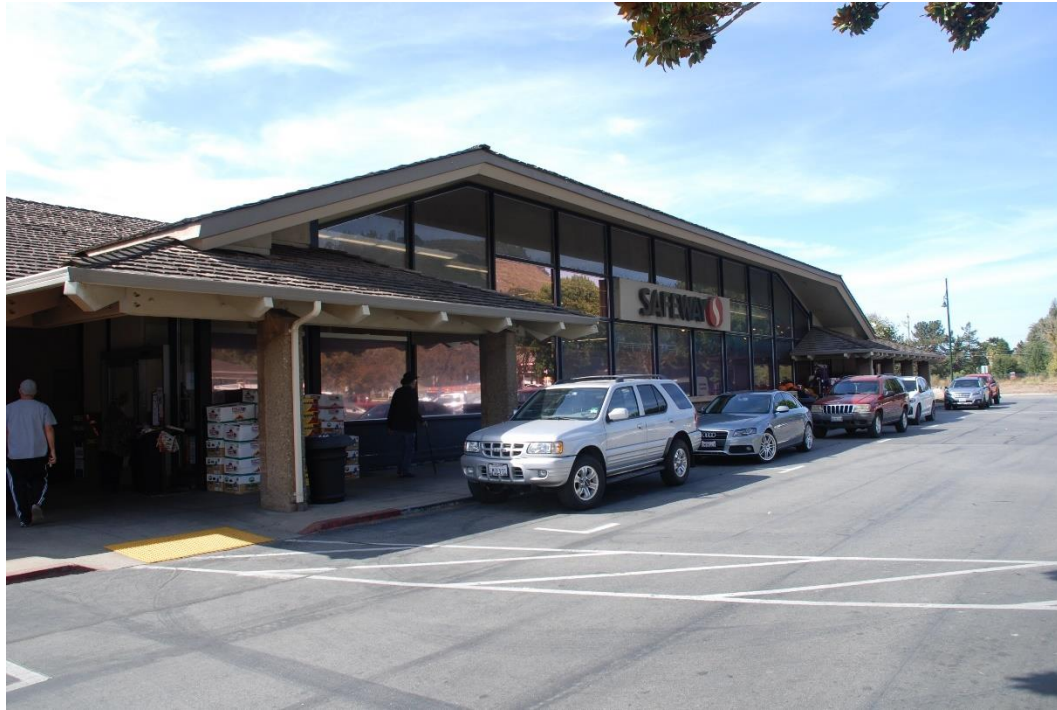
Building A is a large one- and two-story commercial building with a roughly rectangular footprint consisting of the largest retail space at the northwest, and smaller rectangular commercial spaces at the southeast side. The building is aligned at the rear of the property, with its long axis parallel to Carmel Valley Road. The primary façade of the Safeway store consists of expansive fixed aluminum-frame glazing set beneath the deeply overhanging shingle-clad roof (**Figure 2**). Hipped awnings clad in shingles intersect the eaves of the primary roofline at each side of the primary façade, and are supported by concrete piers.

Figure 2. Building A, northeast façade of Safeway store, view southwest.

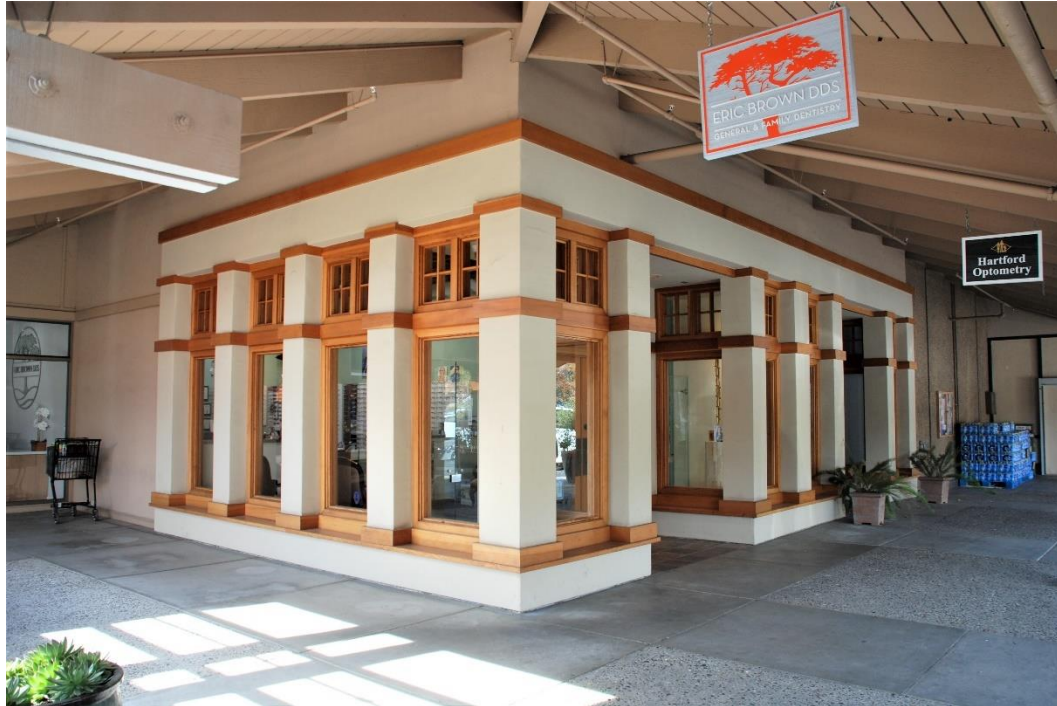
The two storefronts to the southeast of Safeway have been modernized within recent decades, featuring a series of rectangular and square, wood-frame windows set between stucco-clad pilasters with wood-detailed capitals and trim (**Figure 3**). Storefronts at the recessed east portion of the northeast facade and the southeast façade of Building A feature full-height wood- and aluminum-frame glazing and glazed metal doors (**Figure 4**).

Figure 3. Building A, Two storefronts to immediate southeast of Safeway, view southwest.

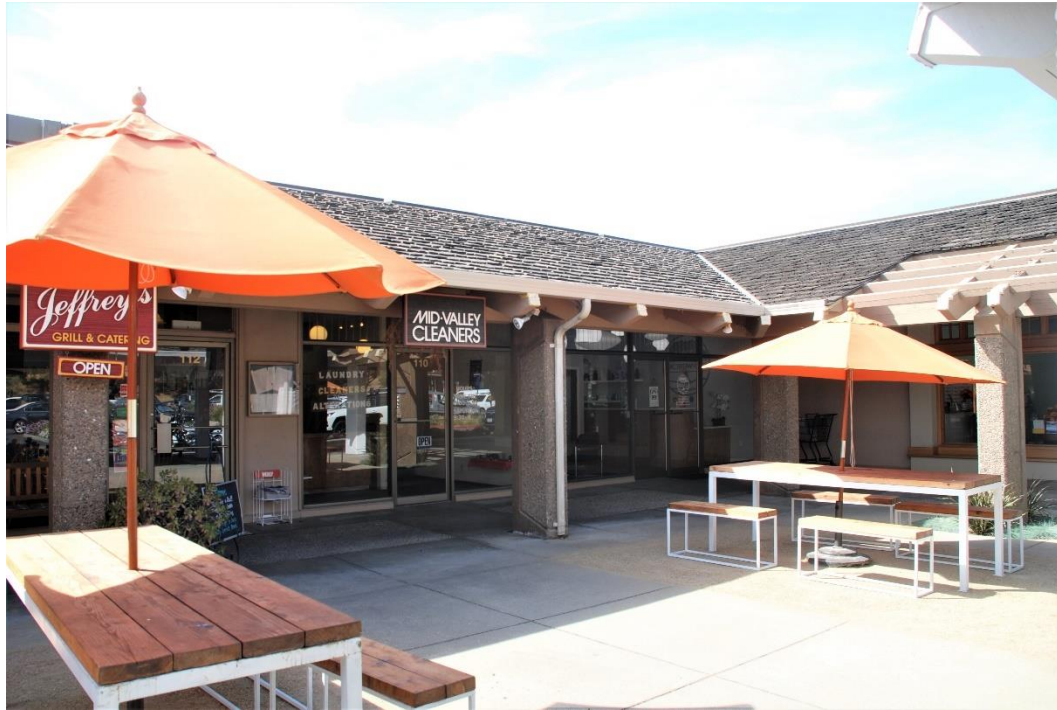
Figure 4. Building A, northeast façade of southeast wing, view southwest. The edge of the covered walkway is visible at the upper right.

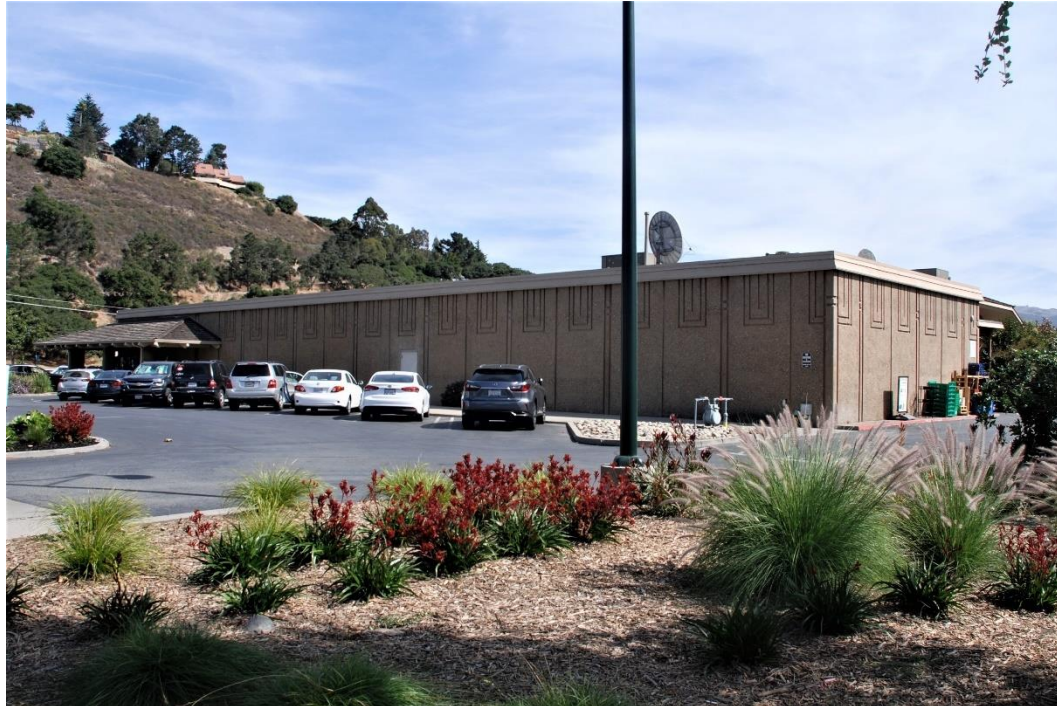
The high one-story northwest and southwest façades of the Safeway portion of Building A overlook a parking and freight loading area respectively. The hipped awning extends around the northwest corner of the building, and the façades feature exposed aggregate with an rectilinear intaglio design and flat, smooth pilaster-like details at regular intervals (**Figure 5 and Figure 6**). The lower hipped roof with deep overhang and concrete piers with exposed aggregate and intaglio extend across the southeast façade of Building A, which overlooks a passage between the courtyard and rear loading dock area (**Figure 7 and Figure 8**).

Figure 5. Building A, northwest façade and western portion of southwest façade, view northeast. Note intaglio wrapping around to rear of building.

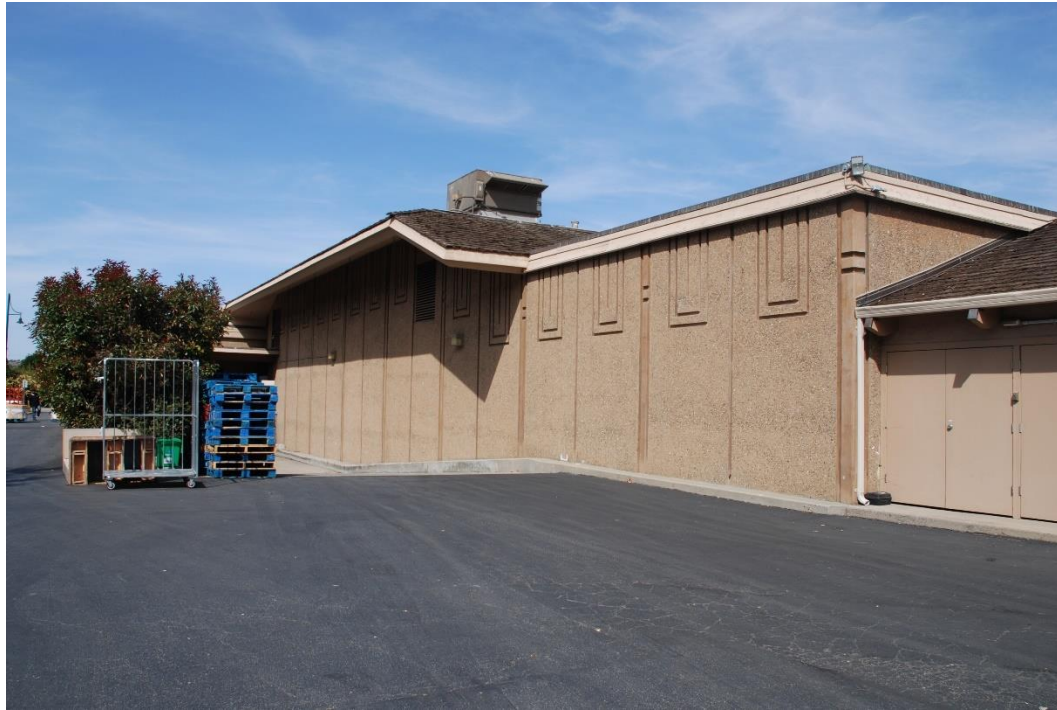
Figure 6. Building A, central portion of southwest façade, including Safeway loading dock, view northwest.

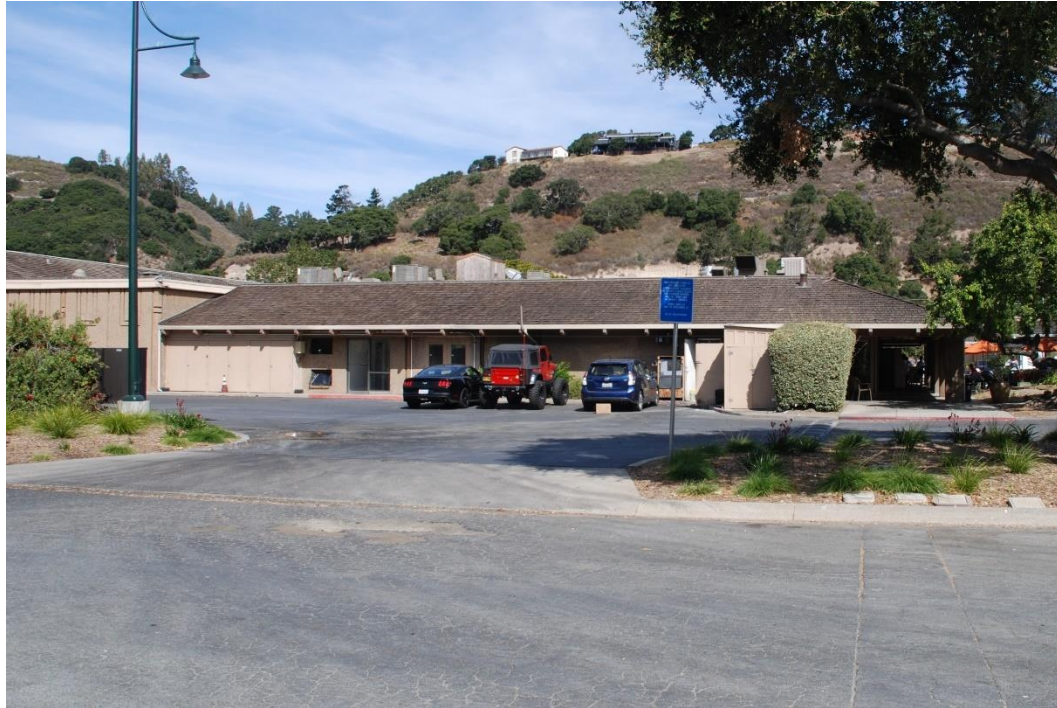
Figure 7. Building A, southeast portion of southwest façade, rear of stores to southeast of Safeway, view northeast.

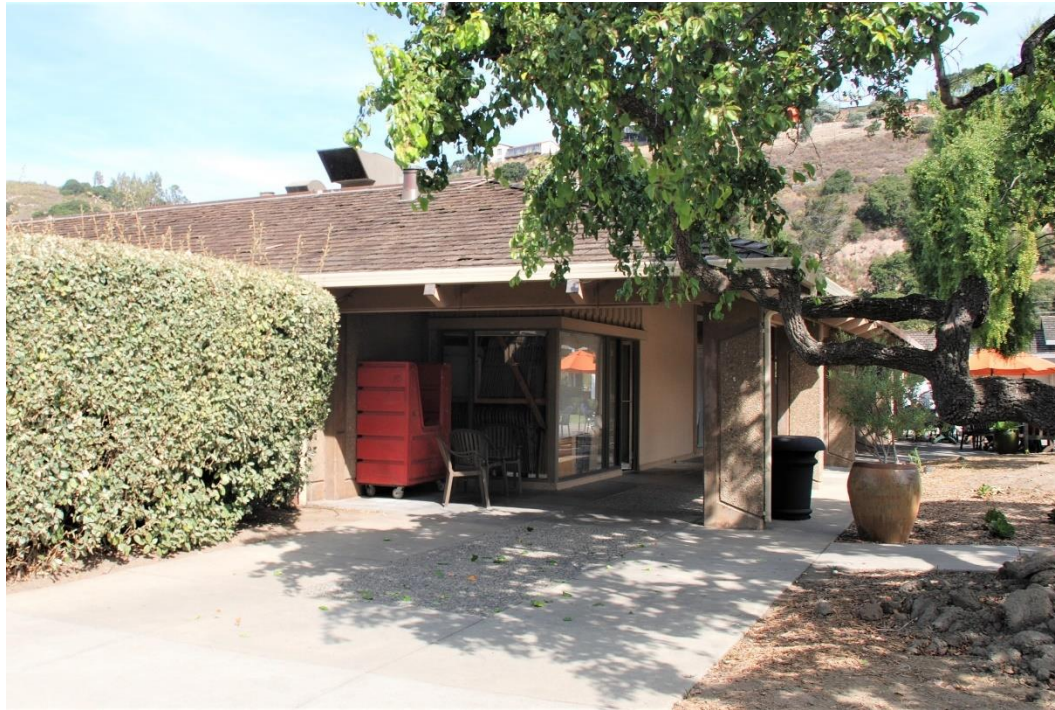
Figure 8. Building A, view northeast across southeast façade.

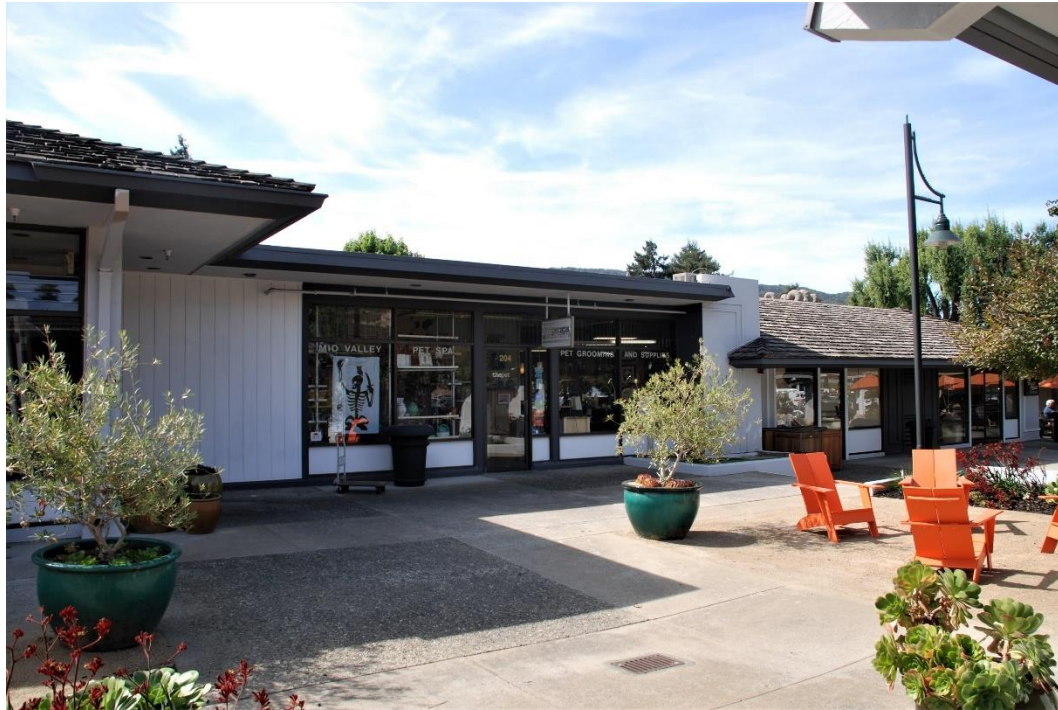
The one- and two-story Building B of the shopping center is smaller than the adjacent Buildings A and C, and is set at the rear, southeast corner of the parcel at the northwest corner of Berwick Drive and Center Street. It has a composite rectangular footprint, and is aligned with its long axis parallel to Carmel Valley Road. The storefronts primarily face the northeast. Building B consists of three segments constructed later than the adjacent Buildings A and C, and includes two rectangular hipped-roof portions connected by an L-shaped flat-roofed portion wrapping around the southwest façade of the southeast hipped-roof section. In contrast to Building A and Building C, the hipped-roof portions of Building B feature shallower roof overhangs, enclosed eaves, and widely-spaced, simple wood posts rather than concrete piers. The flat-roofed portion is different in character from other buildings in the Mid Valley Shopping Center, with narrow rectangular and ribbon windows and applied wood detail emphasizing the horizontality of its design.

Figure 9. Building B, western portion of northeast façade, overlooking courtyard, view southwest.

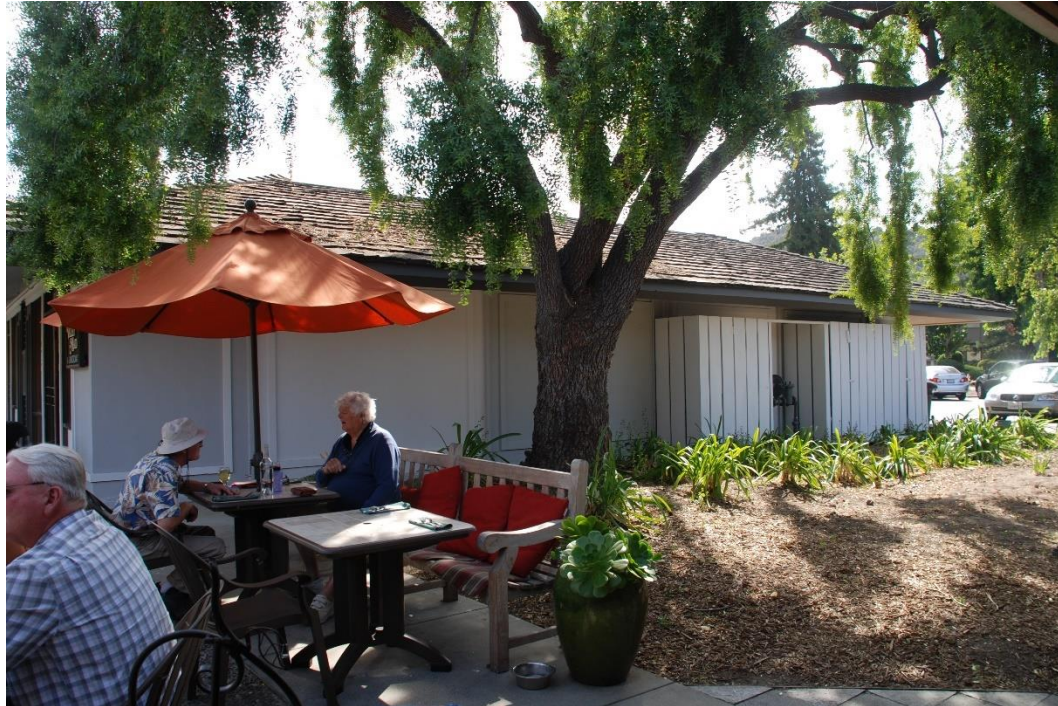
Figure 10. Building B, northwest façade, view southeast.

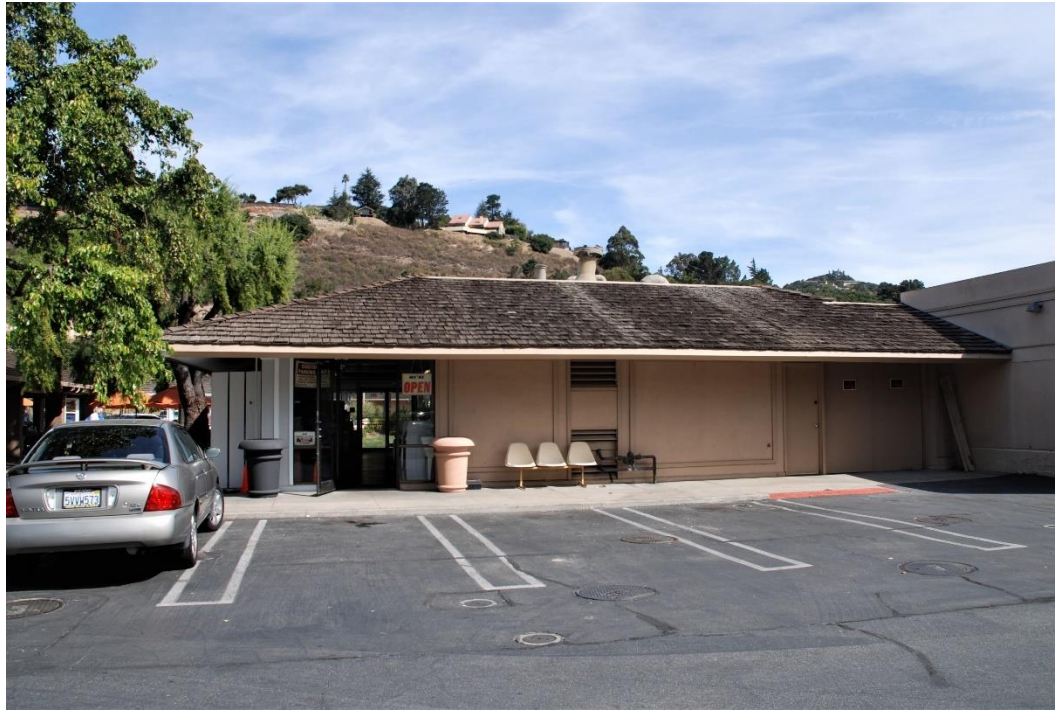
Figure 11. Building B, west portion of southwest façade, view northeast.

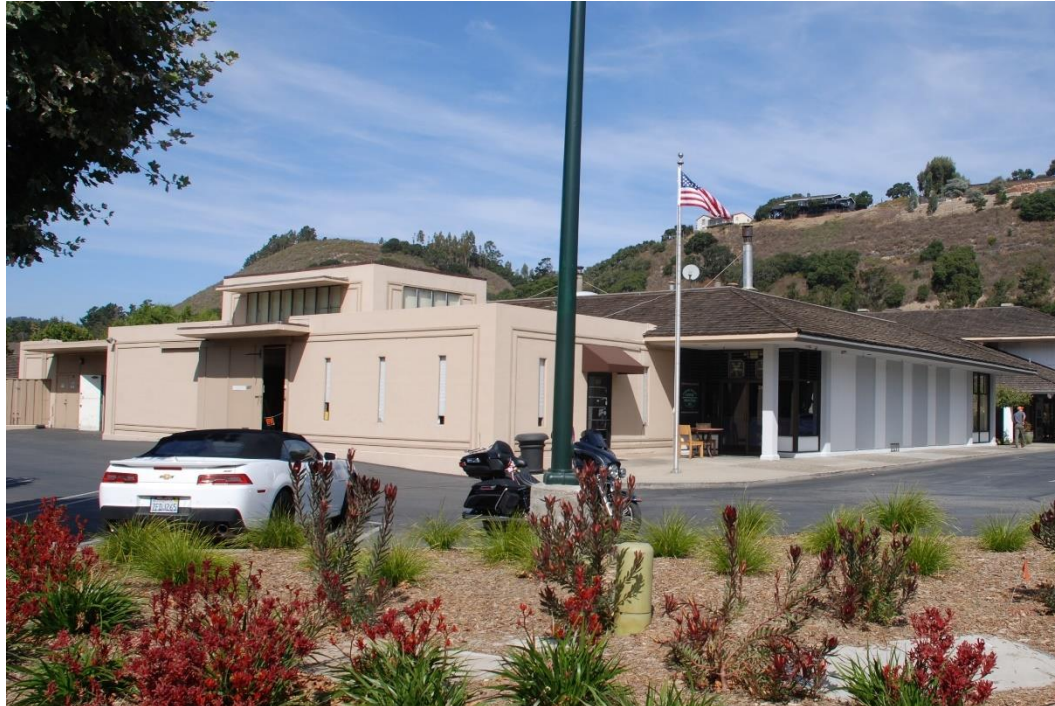
Figure 12. Building B, east portion of southwest façade and southeast façade, view north.

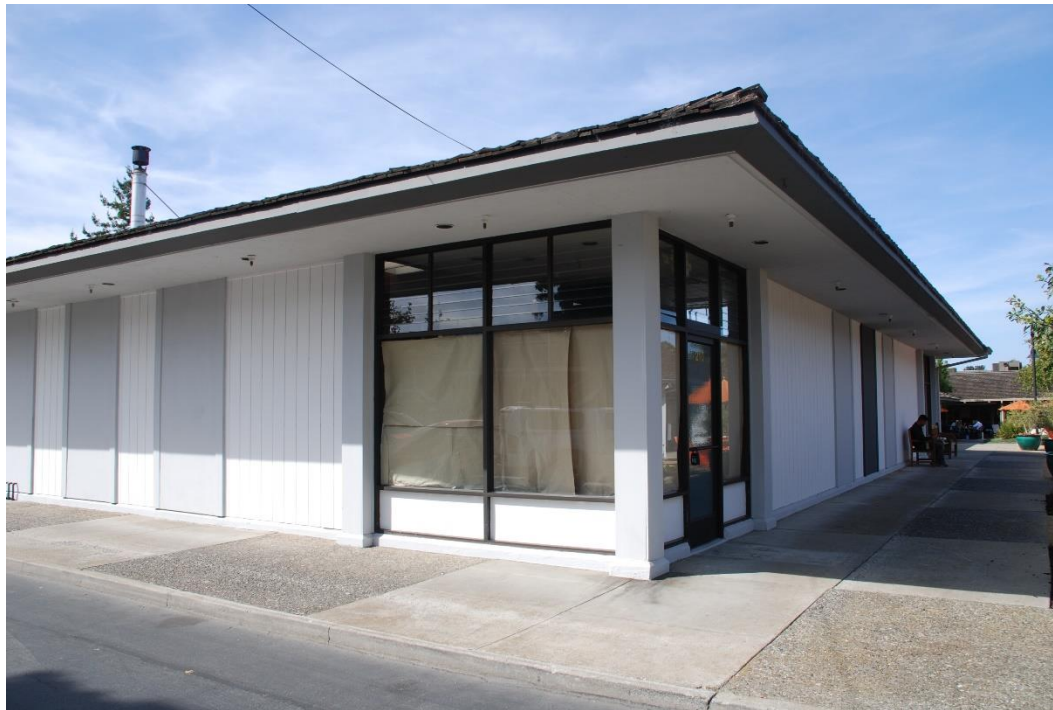
The northwest, hipped-roof portion of Building B consists of storefronts with metal-frame glazing, featuring louvered upper lights at some locations, opaque panel kickplates, and glazed metal doors. The northeast-facing storefront of the central portion of Building B features similar glazing to that used throughout the building (**Figure 9**). Stucco-clad panels are ornamented with rectangular patterns of applied wood trim. Plywood panels are also used at some locations (**Figure 10 and Figure 11**). The flat-roofed one- and two-story central portion of Building B is primarily visible on the rear, southwest façade of the building. It features flat, cantilevered awnings at the first and second stories, narrow rectangular and rectangular ribbons of metal-frame windows. The stucco cladding features a rectilinear pattern of applied wood trim (**Figure 12**). The northeast-facing storefront of the central portion of Building B features similar glazing to that used throughout the building. The southeast, hipped-roof portion of the building features similar storefront glazing to the northwest portion of Building B, with scored plywood panel cladding and stucco segments between the storefronts (**Figure 13**).

Figure 13. Building B, east portion of southeast façade and northeast façades, view west.

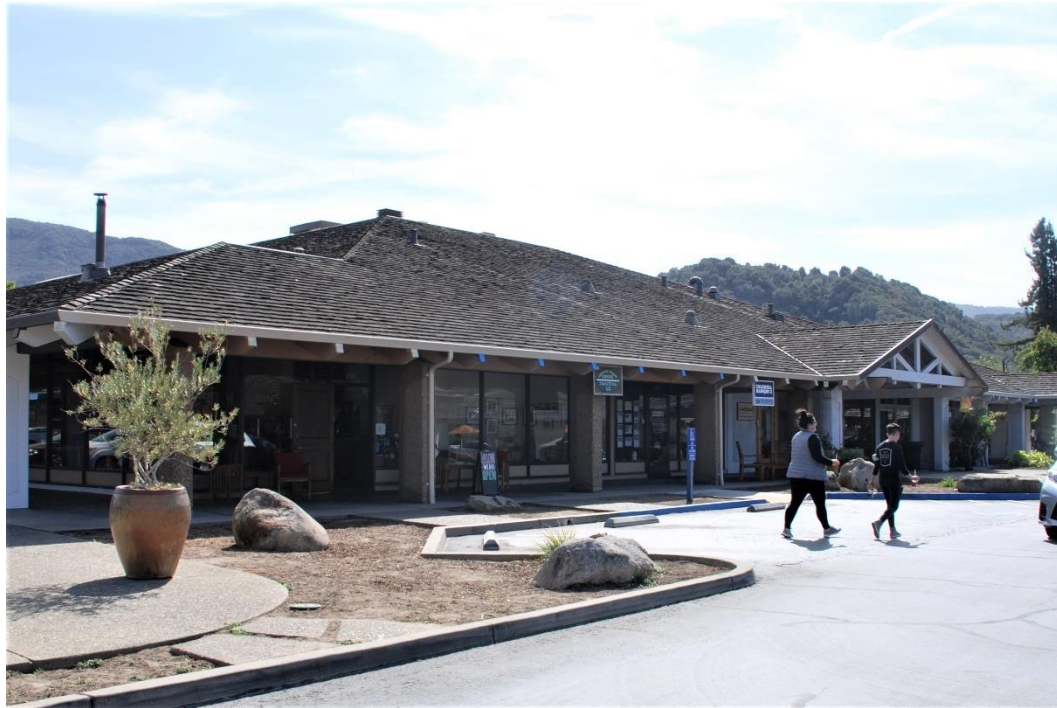
The one- and two-story Building C is located to the northeast of Building B, adjacent to Berwick Drive. It has a rectangular footprint with its long axis parallel to Berwick and Dorris Drives, set at a right angle to Buildings A and B. Like Building A, Building C has a symmetrically stepped, hipped and flat roof clad on its hipped portions with shingles (**Figure 14**). Deep roof overhangs and awnings feature exposed rafters and beams, and are supported by concrete posts of the same character as those at Building A. Storefronts are present on all facades of the building, and typically feature full-height fixed, rectangular metal- and wood-frame glazing with opaque panel kickplates and glazed metal doors. Louvered upper lites are present at some locations (**Figure 15 through Figure 20**). There is some variety in the configuration and materials of openings associated with the Building C storefronts, indicating incremental alterations made by various tenants. A cross-gable canopy within the roof overhang is roughly centered on the northwest façade over the entrance to the largest, two-story commercial space within the building. This entrance features an ornamental wood truss within the gable, and square and rectangular wood-frame storefront windows and doors similar in character to those to the southeast of the Safeway store in Building A (**Figure 15**). The central, two-story portion of the southeast (rear) façade of Building C lacks a hipped awning at the first story, and features a similar intaglio design to that employed on the northwest and southwest façades of Building A (**Figure 18**).

Figure 14. Building C, northwest façade, view south.

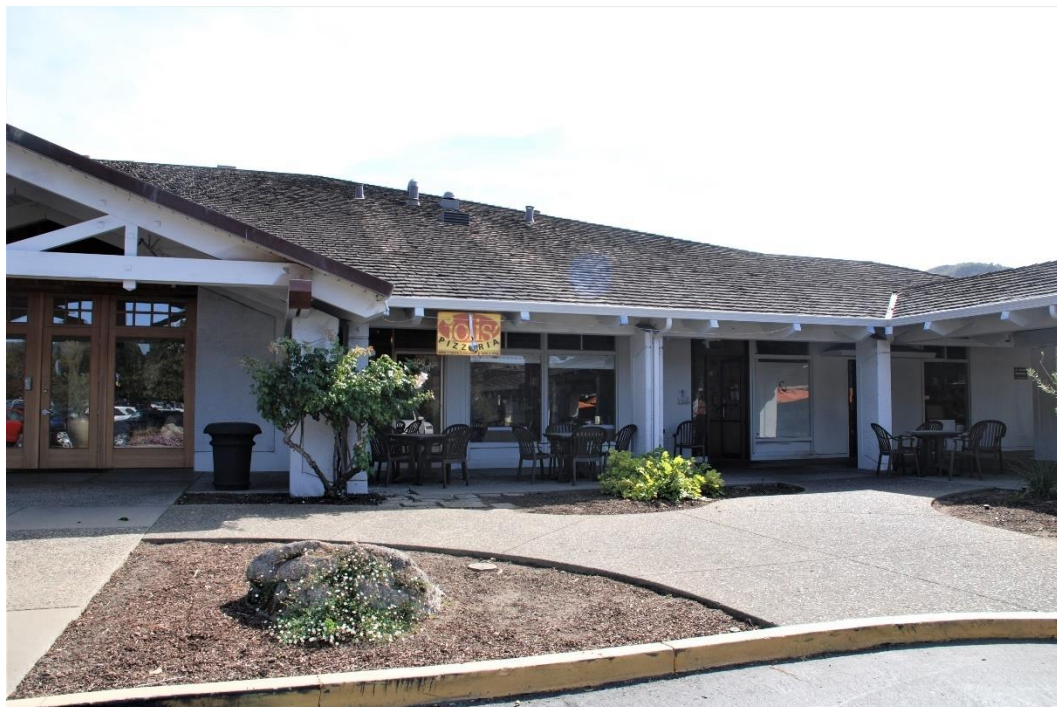
A covered walkway with a narrow, shingle-clad gabled roof connects the southwest corner of Building C to the northeast corner of Building A. It features heavy exposed rafters and beams, and is supported by concrete piers of the same style as present at Buildings A and C.

Figure 15. Building C, south portion of northwest façade, view southeast. Covered walkway attaches to Building C roof at right.

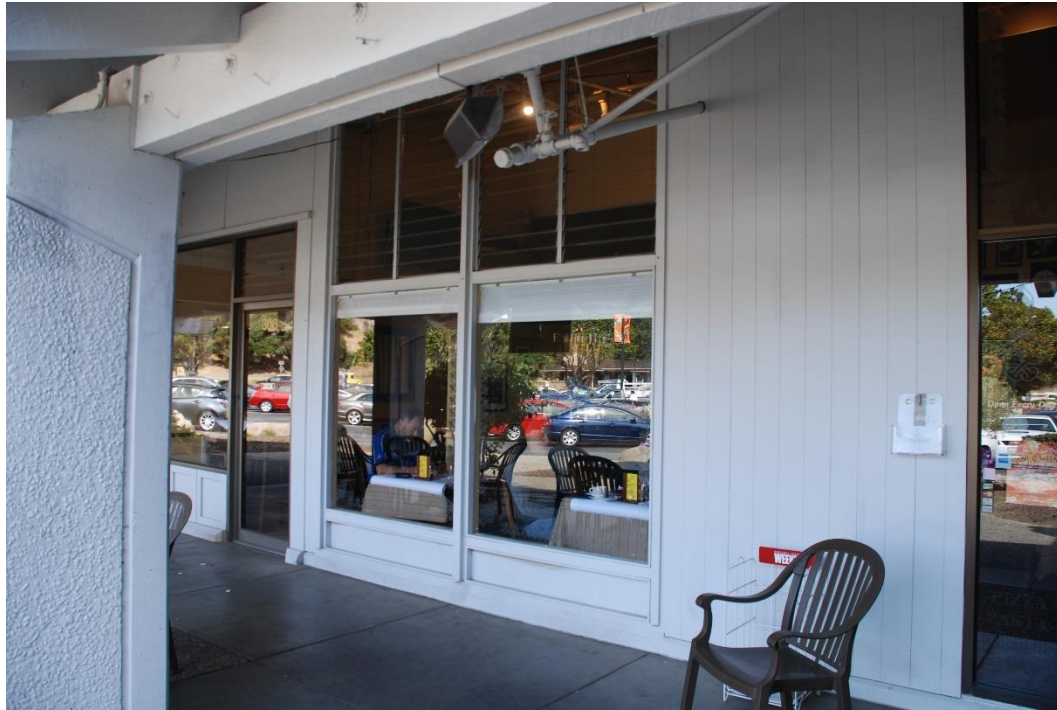
Figure 16. Storefronts at southwest end of Building C, view northeast.

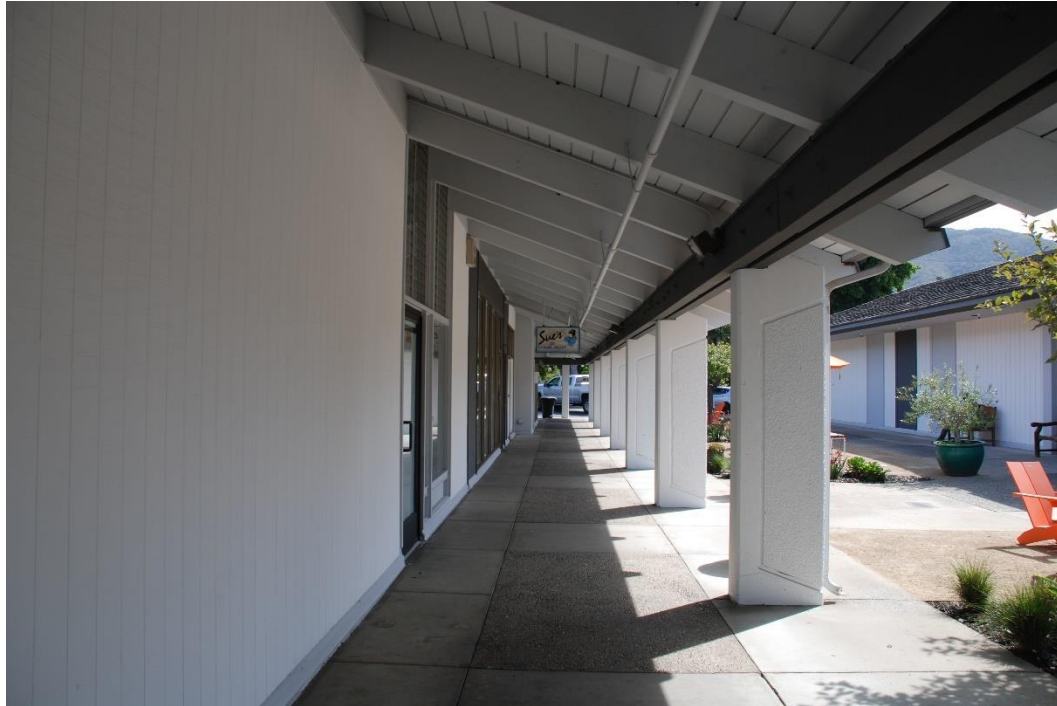
Figure 17. Building C southwest façade, view southeast.

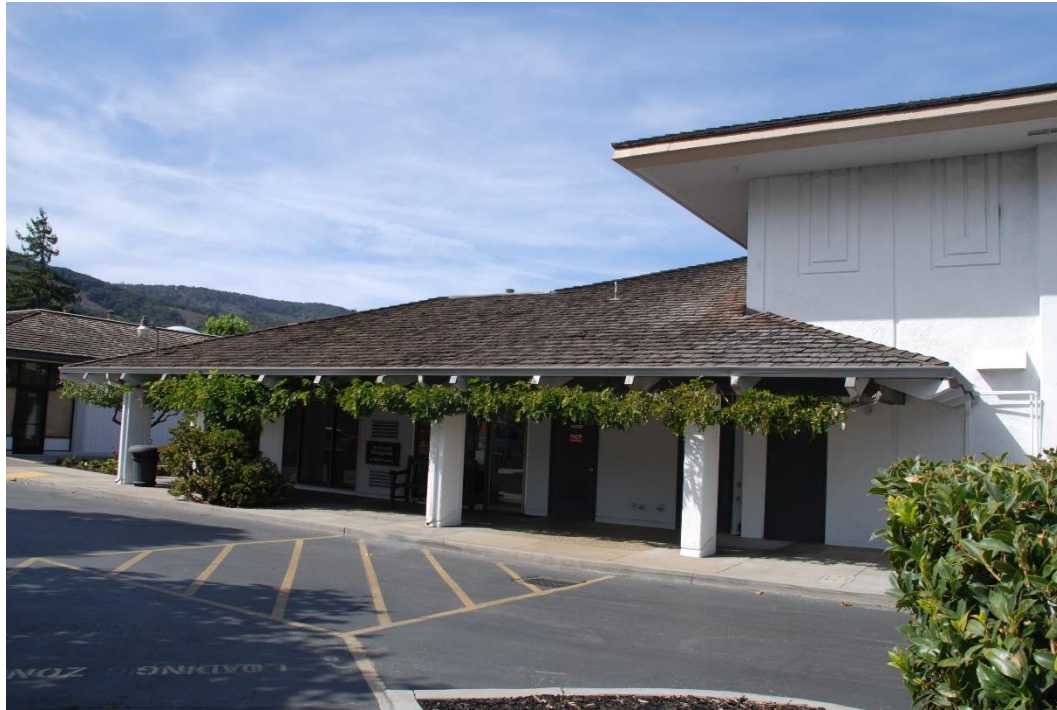
Figure 18. Building C, south portion of southeast façade, view west.

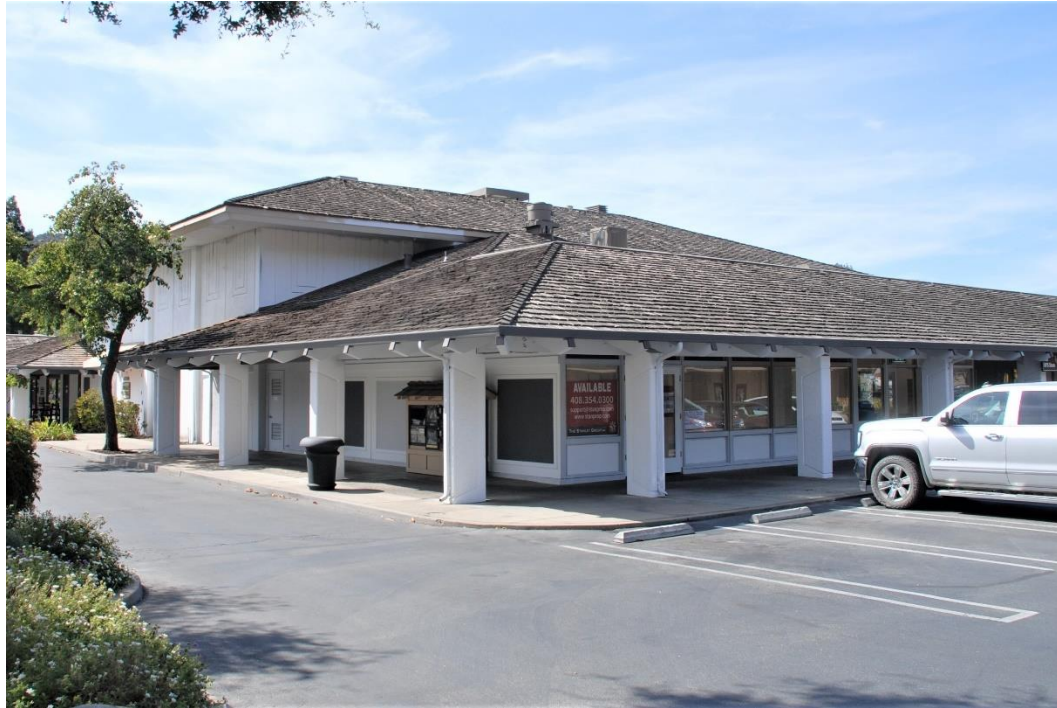
Figure 19. Building C, southeast and northeast façades, view southwest.

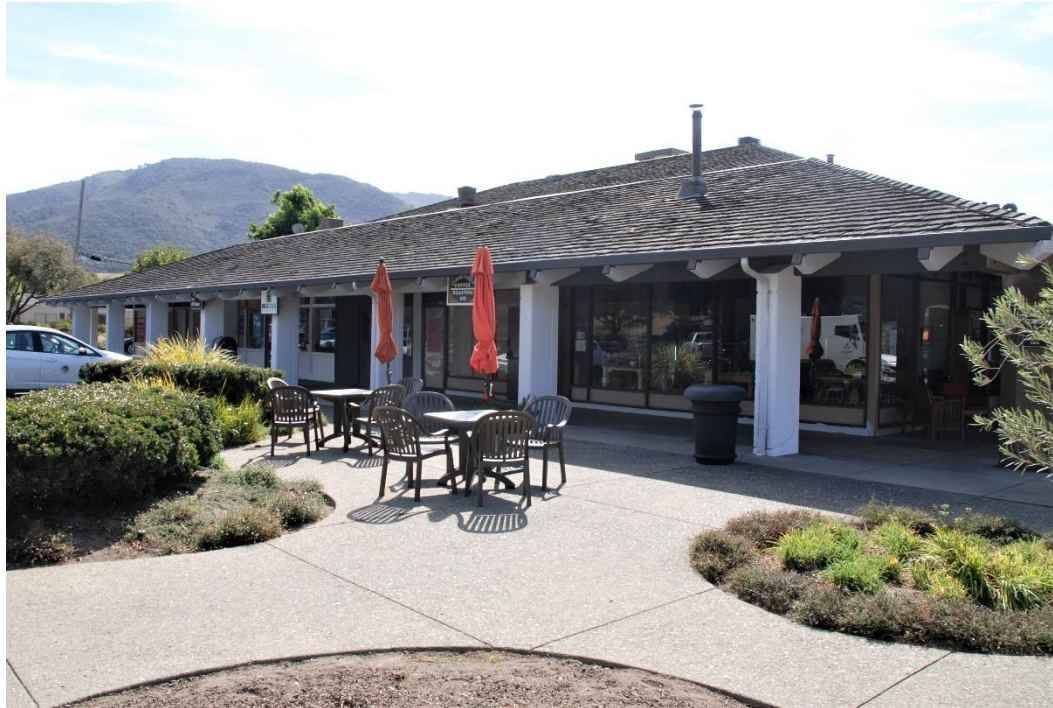
Figure 20. Building C, northeast façade, view southeast.

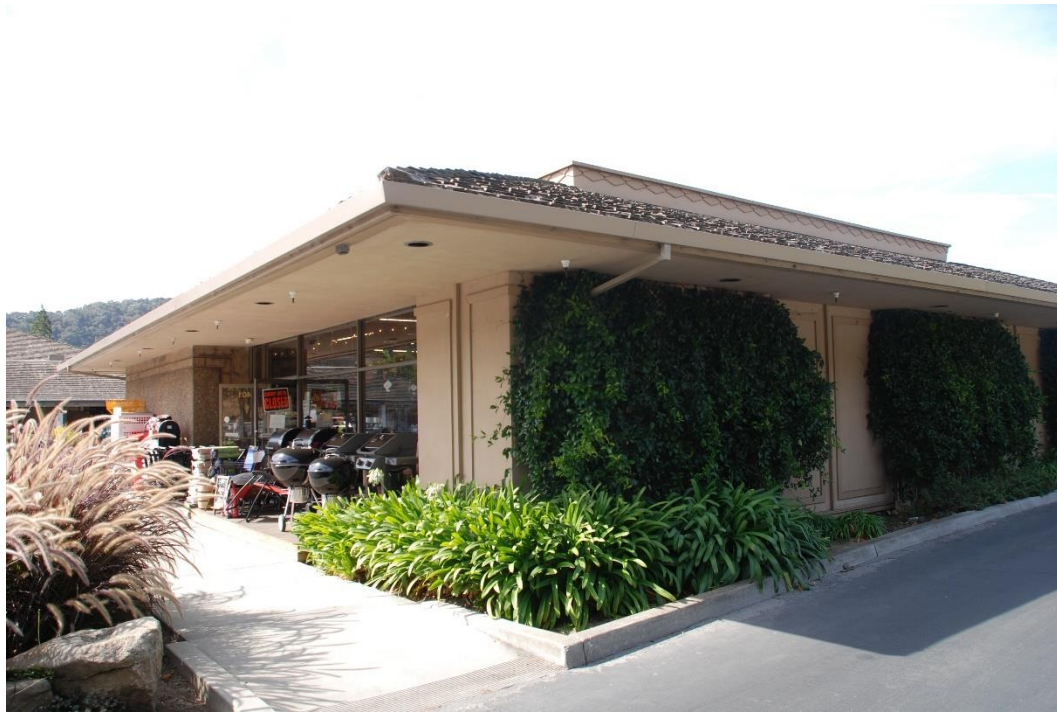
Located at the northeast side of the complex, Building D is a one-story building located adjacent to Carmel Valley Road, separated from Buildings A, B, and C by a large parking lot. It has a rectangular footprint, and is aligned with its long axis parallel to Carmel Valley Road. Building D is capped by a shingle-clad hipped roof with enclosed, overhanging eaves. A rectangular wood parapet at the center of the roof features an applied running band of diamond shapes. The primary entrance to Building B is located within the southeast façade, which features a concrete and exposed aggregate wall at its south end, full-height metal frame glazing with a glazed metal door slightly to the left of center, and stucco cladding with wood trim applied in a rectangular pattern at its north end (**Figure 21**). The northeast façade overlooks a driveway, and is stucco-clad with rectangular-patterned applied wood trim (**Figure 22**). Much of the façade is currently obscured by hedges planted near the building's foundation. A glazed metal double door is located near the west side of the northeast façade. The northwest corner of the building is dominated by a large, rectangular concrete block that intersects and rises above the roofline, featuring concrete, exposed aggregate, and a simple intaglio design on its northeast- and northwest-facing side. The southern portion of the northwest façade is similar in character to the northeast façade, with stucco cladding and applied wood trim (**Figure 23**). The southwest façade features seven evenly spaced concrete pilasters with an exposed aggregate and intaglio design on three sides matching that used on piers at Buildings A and C (**Figure 24**). The west portion of the façade features the applied rectangular pattern of wood trim typical of the northwest and northeast facades. The east portion of the southwest façade includes fixed rectangular metal-frame windows that have been painted with opaque paint. A single, glazed metal door is centered in the southwest façade.

Figure 21. Building D, southeast and northeast façades, view southwest.

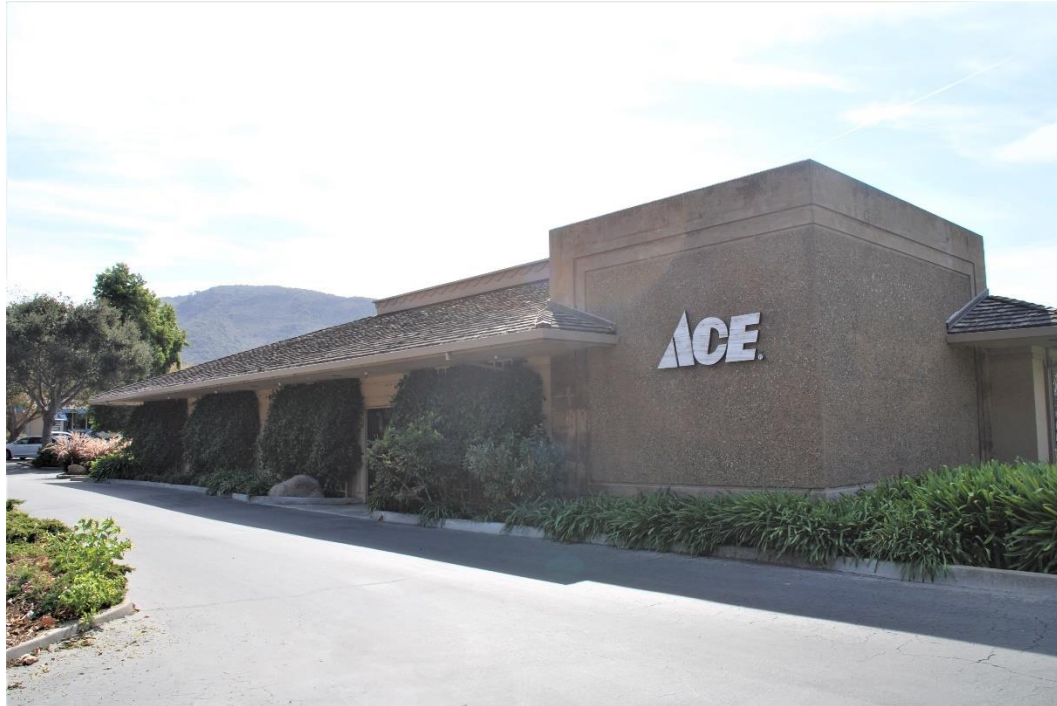
Figure 22. Building D, northeast façade, view southeast.

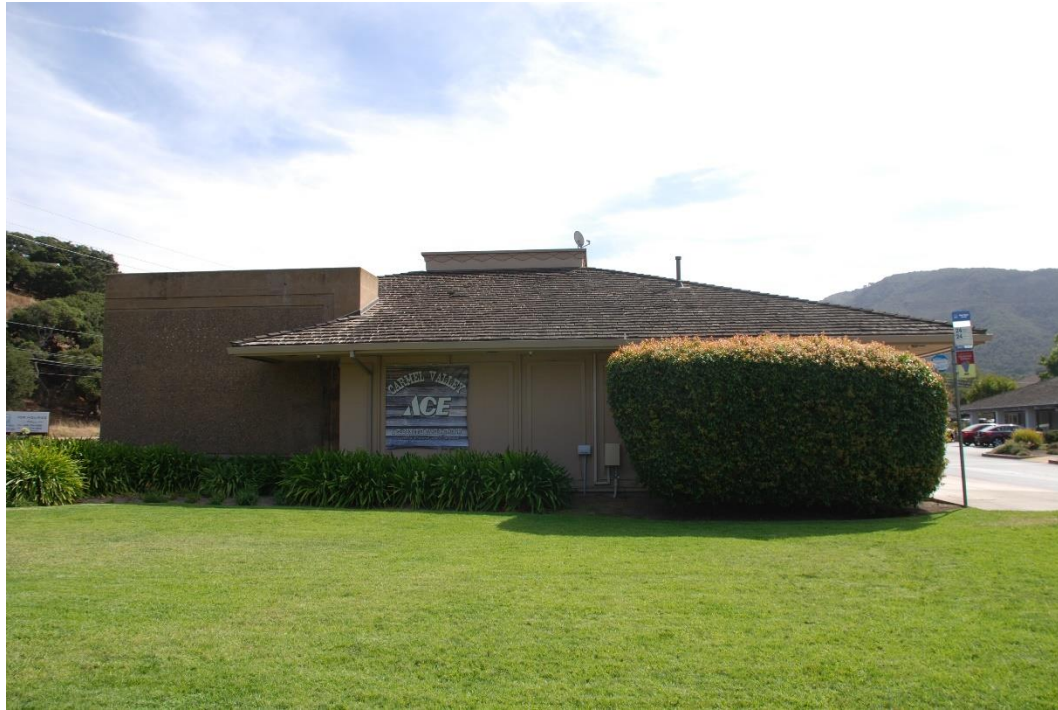
Figure 23. Building D, northwest façade, view southeast.

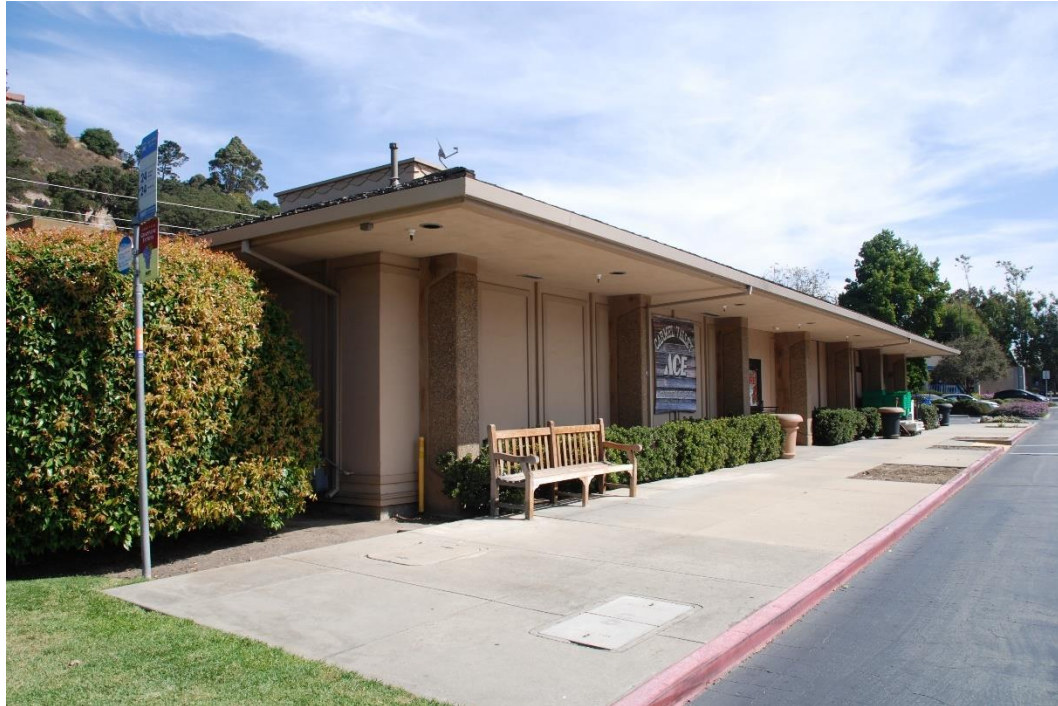
Figure 24. Building D, southwest façade, view east.

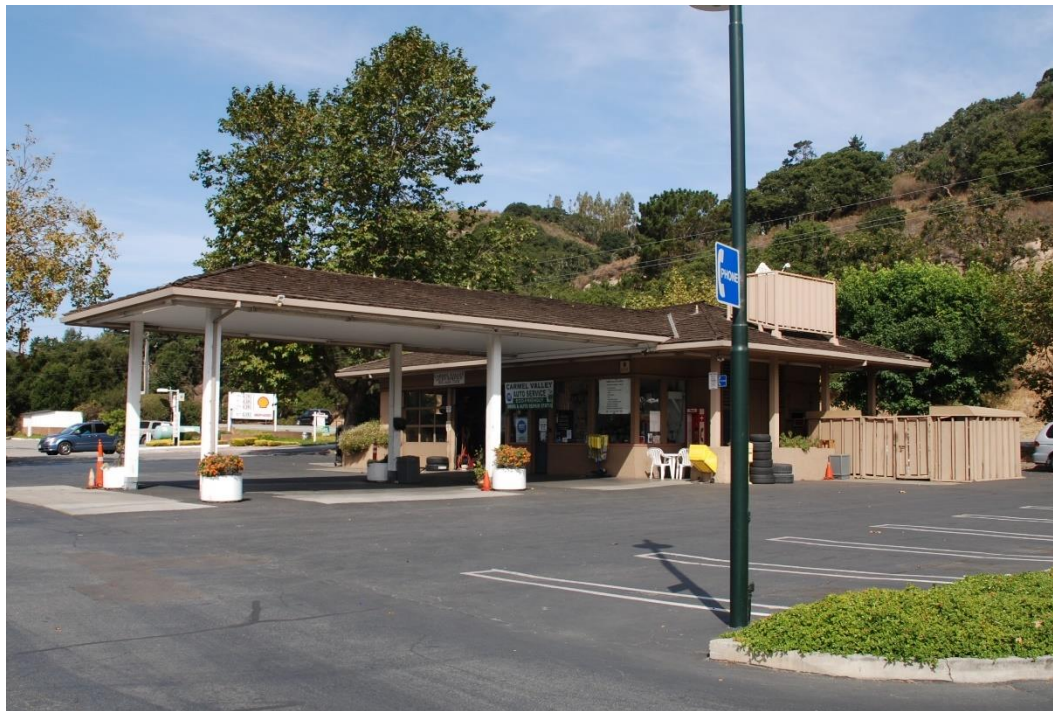
Like Building D, Building E is separated from the other buildings across the large central parking area. It is an automotive service station, located at the northwest corner of the complex, near the intersection of Dorris Drive and Carmel Valley Road. The small, single-story building has a rectangular plan with a long rectangular canopy supported by wood posts extending as a cross gable from the eastern portion of the hipped roof along its southwest façade (**Figure 25**). The roof has a deep overhang and enclosed eaves, supported on the southeast façade by wood posts set in a rectangular concrete and exposed aggregate planter. The primary, southwest façade includes a storefront portion at its east half, with fixed, wood-frame glazing wrapping around to the southeast façade and a partially glazed wood entrance door. The lower portion of the façade is clad with exposed aggregate that has been painted. To the left (west) of the storefront, two glazed roll-up utility doors access the vehicle service area (**Figure 26**). At the northwest façade, the lower aggregate-clad portion of the building is stepped out from the façade to provide a planter. The northwest and northeast façades include fixed rectangular wood-frame windows (partially obscured on the northwest façade) and stucco cladding with a rectangular pattern of wood trim similar to that present on Buildings B and D (**Figure 27**). The southeast façade is partially obscured by a wood-fenced trash enclosure at the building's northeast corner. Two unglazed entrances on this façade, set beneath large louvered metal panels and to either side of a stucco panel with a rectangle of wood trim, appear to access restroom or office portions of the service station (**Figure 28**). A metal mechanical enclosure is located on the southeast facing roof slope.

Figure 25. Building E, southwest and southeast façades, view northwest.

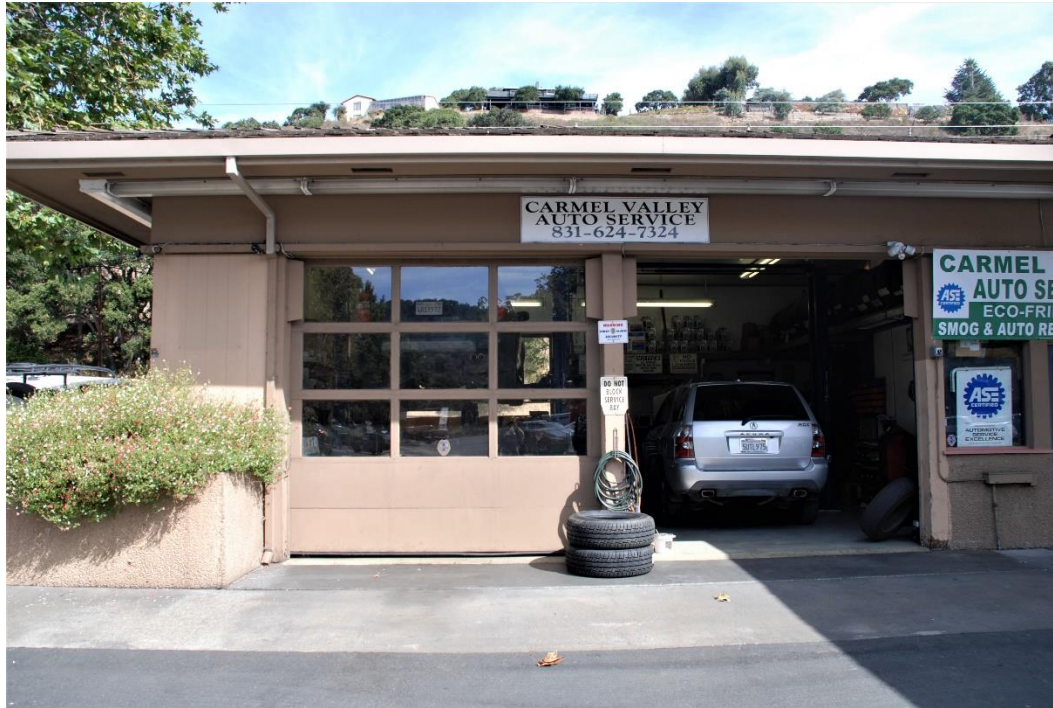
Figure 26. Building E, roll-up doors at west side of southwest façade, view northeast.
