RE: Mid Valley Shopping Center Phase One Historic Assessment

**DPR 523A and 523B forms for the Mid Valley Shopping Center**

Page 1 of 42 Resource name(s) or number (assigned by recorder) Mid Valley Shopping Center

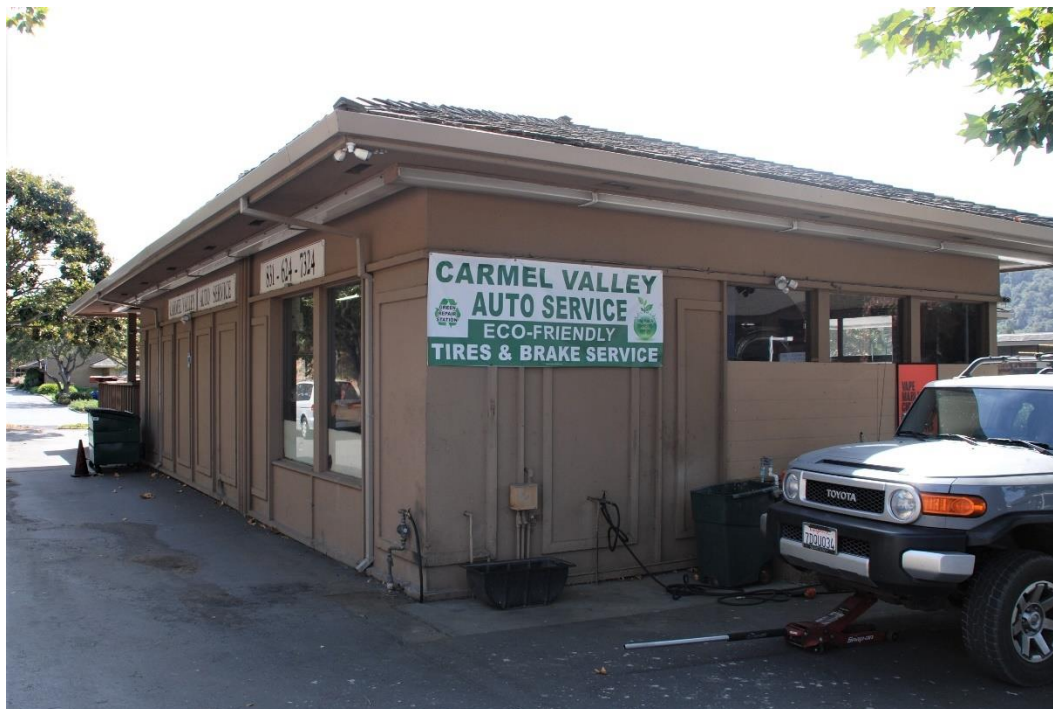
Figure 27. Building E, northwest and northeast façades, view southeast.

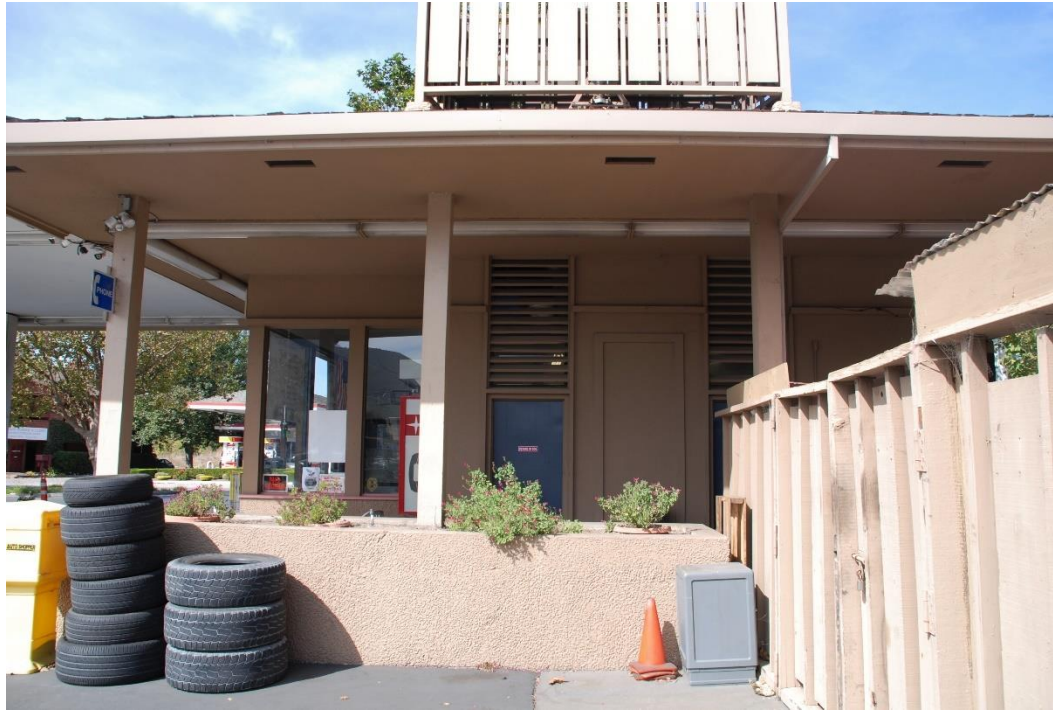
Figure 28. Building E, southeast façade, view northwest.

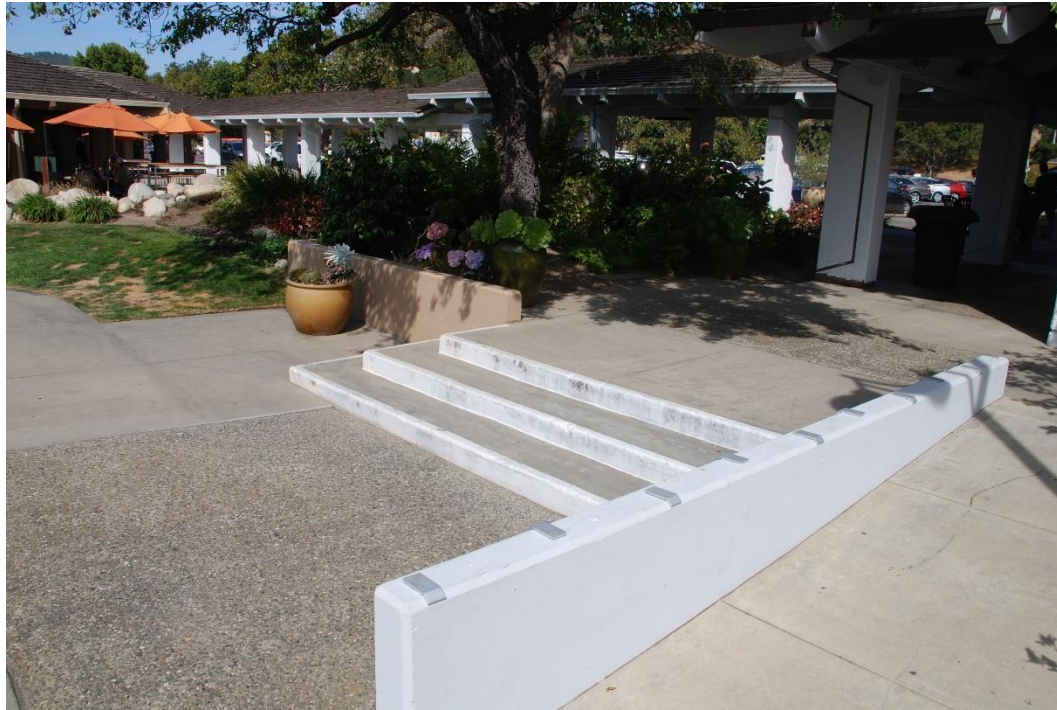
A rectangular lawn extends to the northwest of Building D. A large, central seating area featuring a two-level patio finished with smooth scored concrete, aggregate, and decomposed granite is located in the open space between Buildings A, B, and C, separated from the parking area by a covered walkway supported by concrete piers with exposed aggregate on three sides (**Figure 29 through Figure 31**). The open space includes wide, central steps between the two patio levels, and an irregular, curved lawn area with a linear stone feature. A second, smaller seating area consisting of a concrete and aggregate patio with curved planted beds is located at the northwest corner of Building C. Smaller planted beds are located at various locations along the pedestrian walkways of Buildings A, B, and C. Segments of each building feature hedges planted adjacent to the building façades. Beds with mature trees line the property boundaries on all four sides of the block.

Figure 29. Courtyard between Buildings A, B, and C, view northwest toward covered walkway.

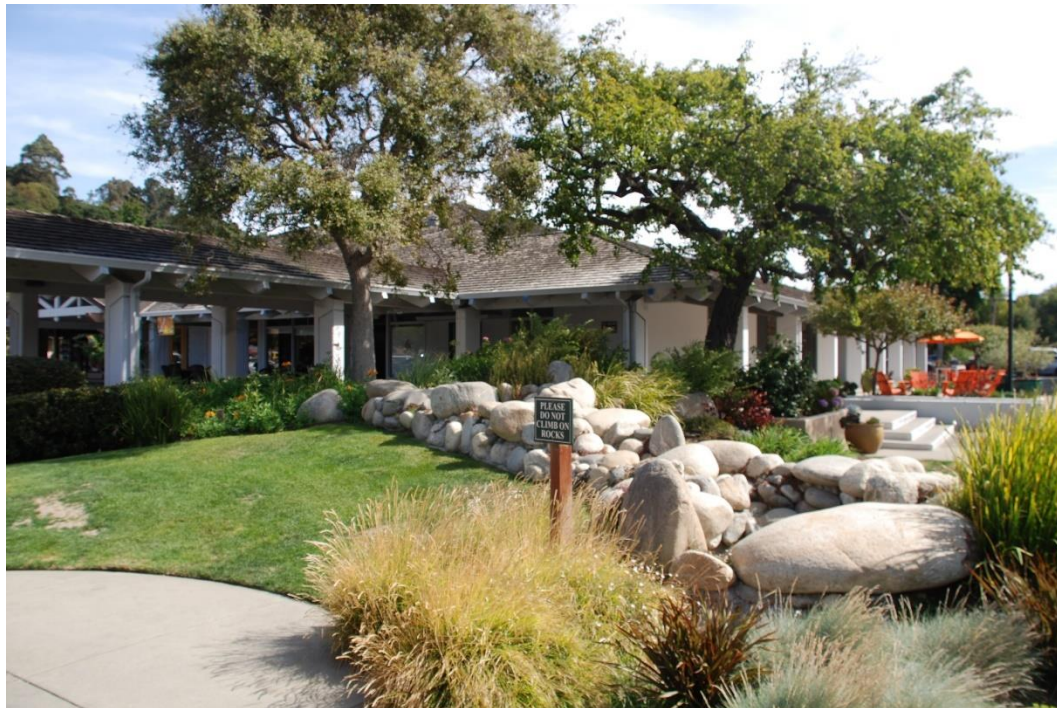
Figure 30. Courtyard between Buildings A, B, and C, view east toward Building C.

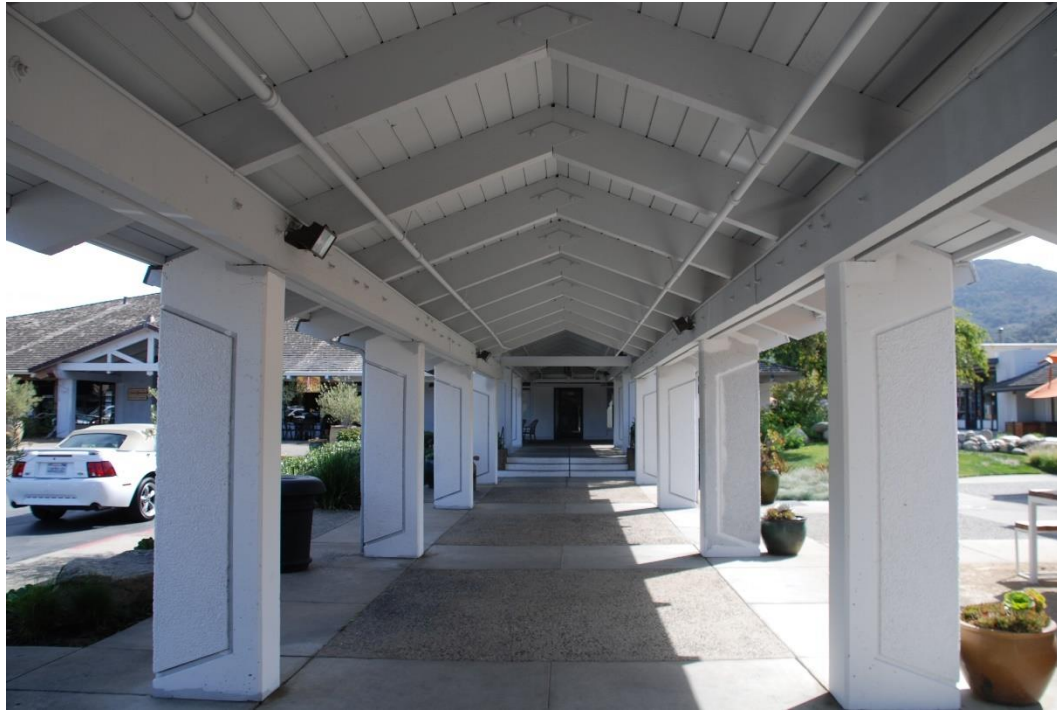
A covered walkway with a narrow, shingle-clad gabled roof connects the southwest corner of Building C to the northeast corner of Building A. It features heavy exposed rafters and beams, and is supported by concrete piers of the same style as present at Buildings A and C.

Figure 31. Covered walkway between Buildings A and C, view southeast.

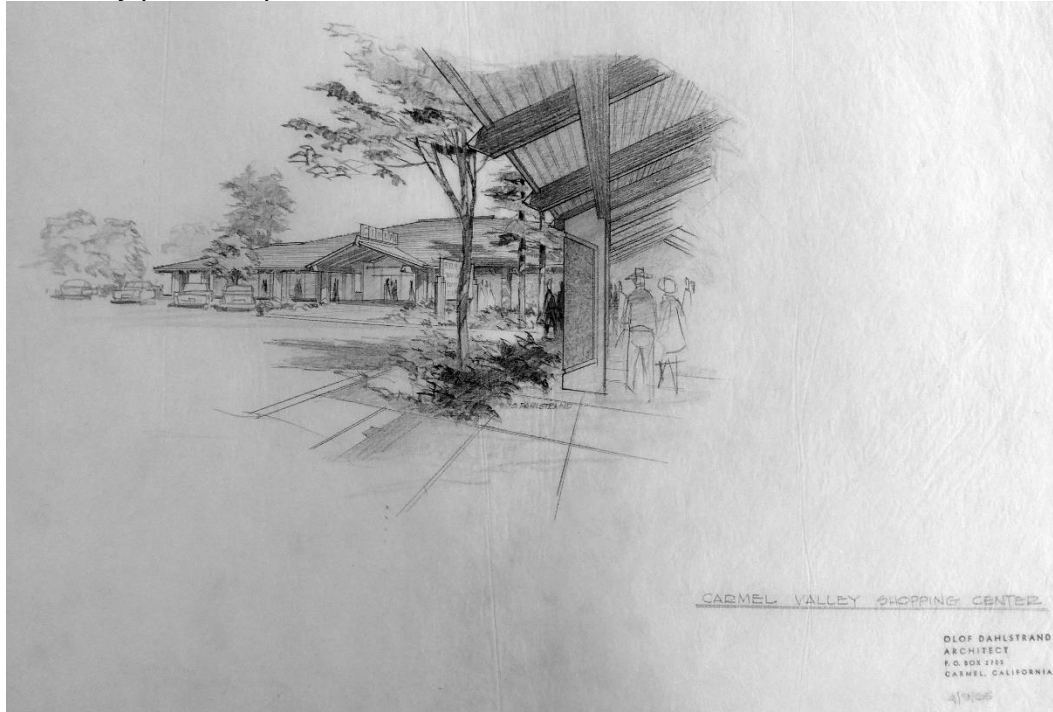
Figure 32. April 1965 drawing by Olof Dahlstrand of the proposed covered walkway and theater entrance (Building C). Source: CED.

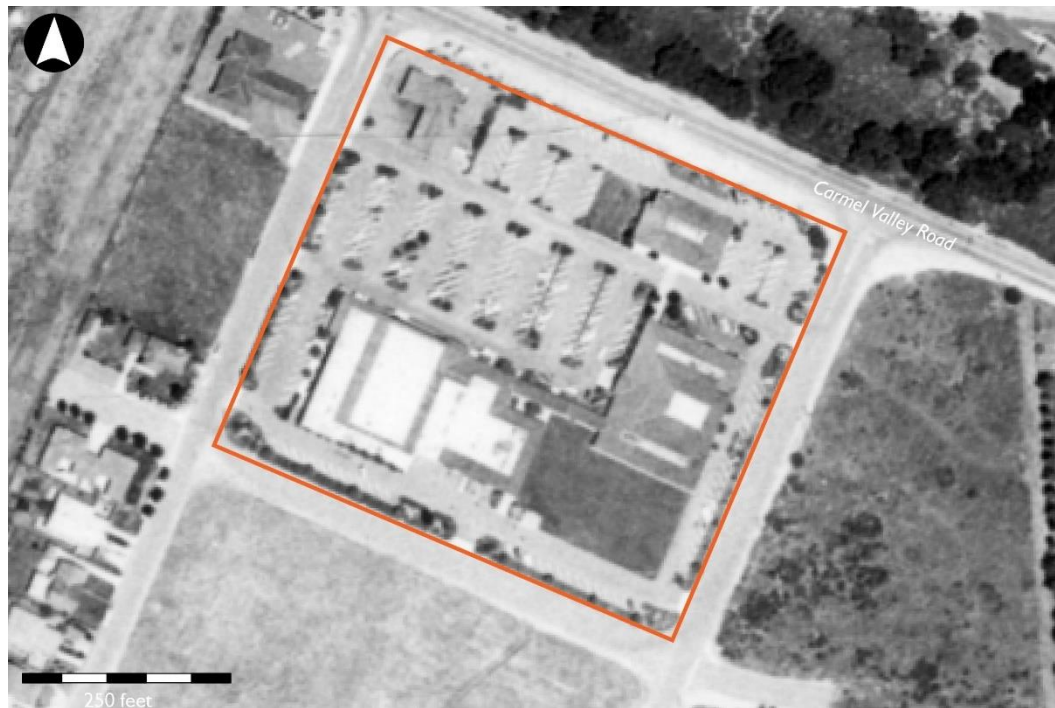
A 1971 aerial photograph of the area shows that in that year, Buildings A, C, D, and E and the covered walkway between Buildings A and C had been constructed in their current locations (**Figure 36**). The configuration of the parking areas, planting beds within the parking lots, pedestrian crossing and lawn adjacent to Building D appear to have been very similar, if not identical, to today's configuration. The greatest difference between the 1971 photograph and today's shopping center is at the southeast corner, where the area now occupied by Building B, and the eastern portion of the courtyard between Buildings A, B, and C appears to have been a large lawn in 1971.

Figure 36. 1971 aerial photograph of Mid Valley Shopping Center. Source: Western Aerial Contractors, Inc., Flight ABG-1971, Frame 1mm-62. Collection of UC Santa Barbara Library, edited by Page & Turnbull.

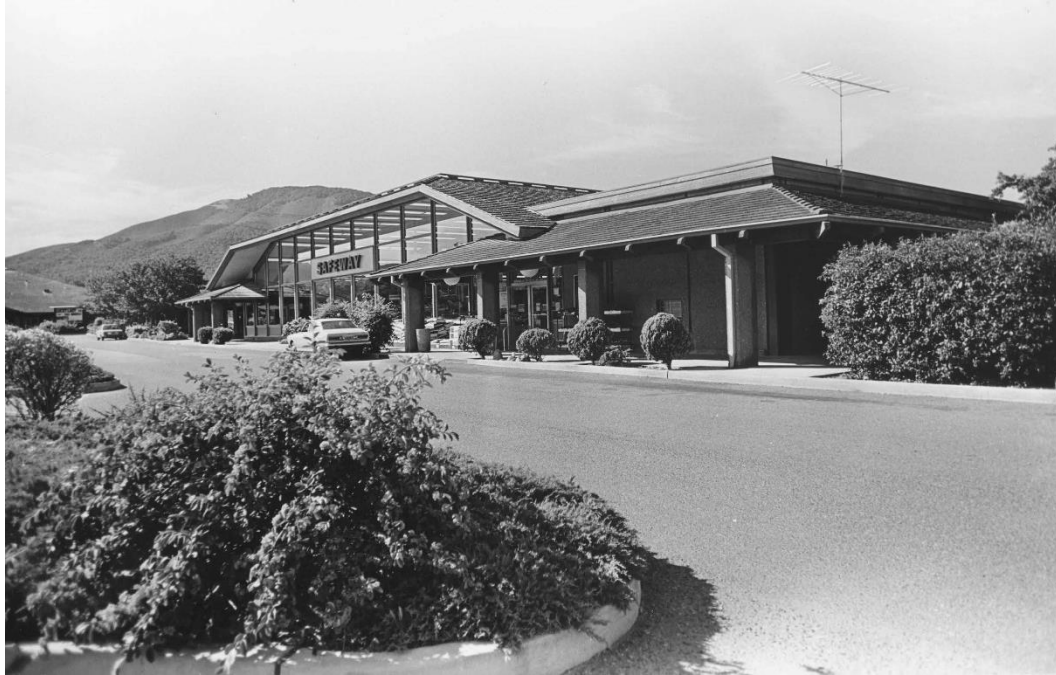
Four photographs taken in about 1974 show the primary façade of the Safeway store in Building A (**Figure 37**), the southeast (rear) façade of what was then the Valley Cinema and shops in Building C (**Figure 38**), the northwest and northeast façades of what was then the Crocker-Citizens National Bank, Building D (**Figure 39**), and the covered walkway between Buildings A and C (**Figure 40**).

Figure 37. Building A, ca. 1974, view southeast.

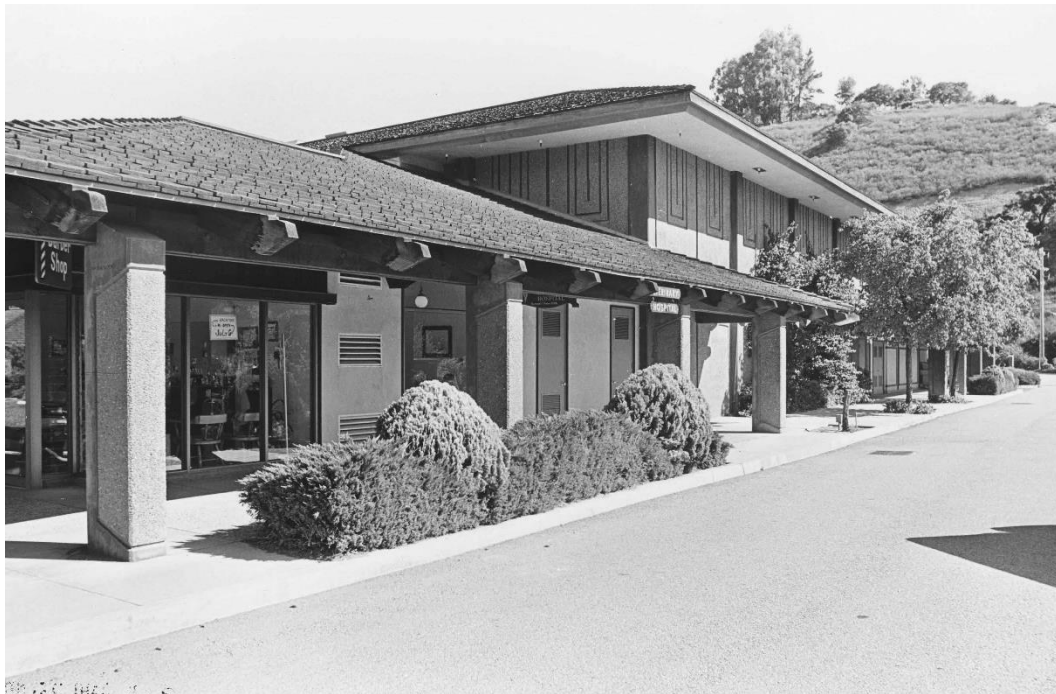
Figure 38. Building C, ca. 1974, view north.

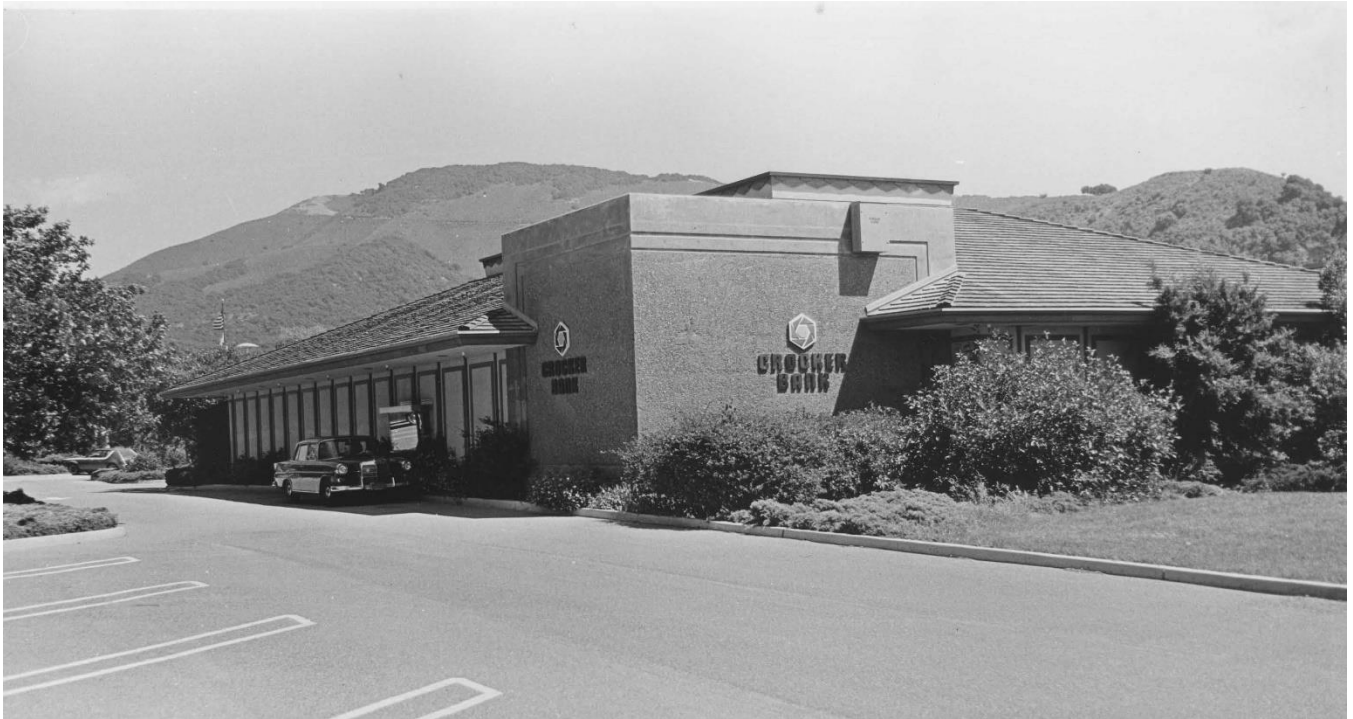
Figure 39. Building D, ca. 1974, view southeast.

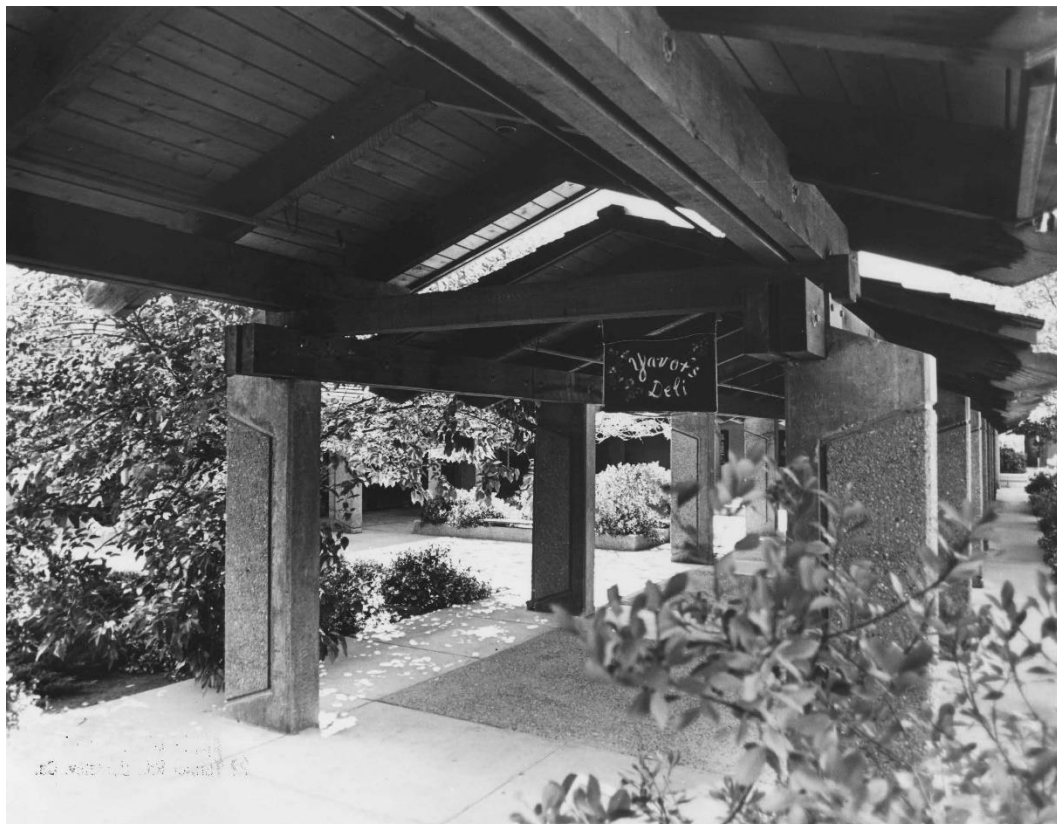
Figure 40. Covered walkway between Buildings A and C, ca. 1974, view northwest.

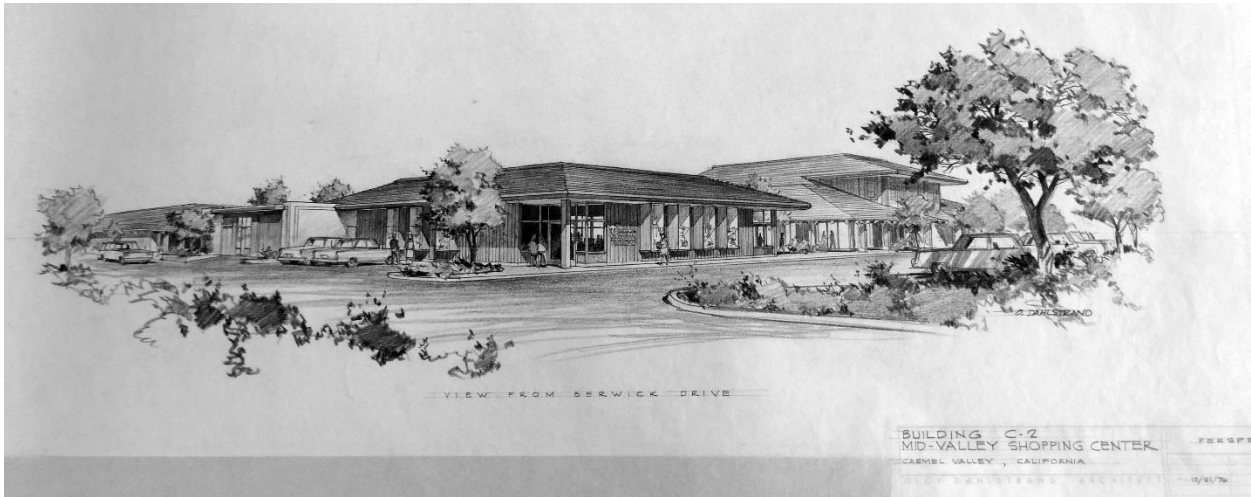
Dahlstrand's 1976 and 1981 perspective drawings of the proposed Building B and Building B expansion are very similar to the extant building, suggesting that this architect was also responsible for the design of these later elements of the shopping center, as well as the design of the courtyard between Buildings A, B, and C (**Figure 41 through Figure 43**). Similarly, a ca. 1976-1981 oblique aerial view drawn by Dahlstrand shows the building configurations, overall style, and landscape features (**Figure 44**). If the landscaped courtyard between Buildings A, B, and C was built as depicted in Figure 42, the accessibility ramp required removal of a portion of the original staircase between patio levels.

Figure 41. 1976 drawing by Olof Dahlstrand, depicting proposed design of Building B, looking north across southwest and southeast façades. Source: CED.
